95年0609豪雨

南投縣—仁愛鄉大同村

950609 豪雨-南投仁愛-001

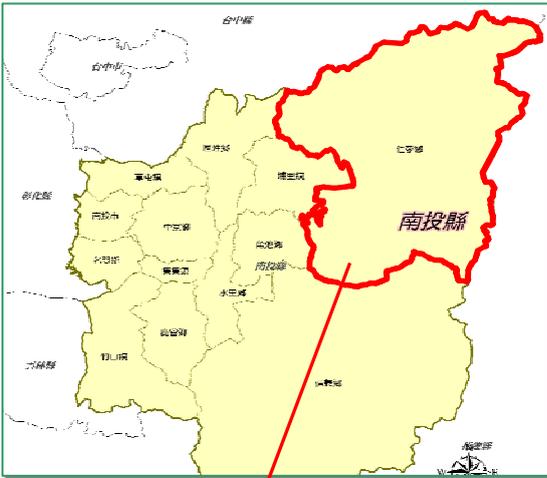
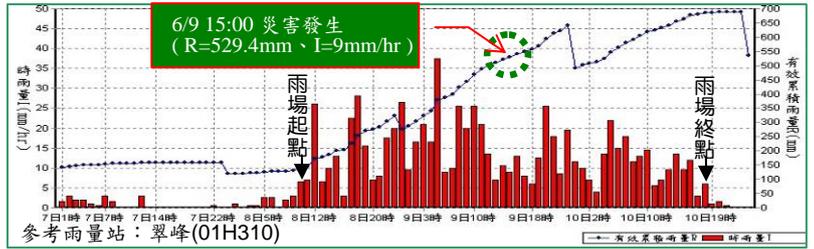
- ❖ 災區位置：仁愛鄉大同村
- ❖ 災害發生時間：6月9日15時
- ❖ 災害類型：崩塌災害(山崩、地滑)
- ❖ 有效累積雨量：529.4mm

- ✓ 九號鄉道中斷、建物基礎掏空。
- ✓ 台14線道路龜裂，長約200m。
- ✓ 人命損失：0人
- ✓ 房舍受損：18棟
- ✓ 擋土牆損壞約130公尺。
