# 0604 豪雨

# 南投縣—國姓鄉乾溝村

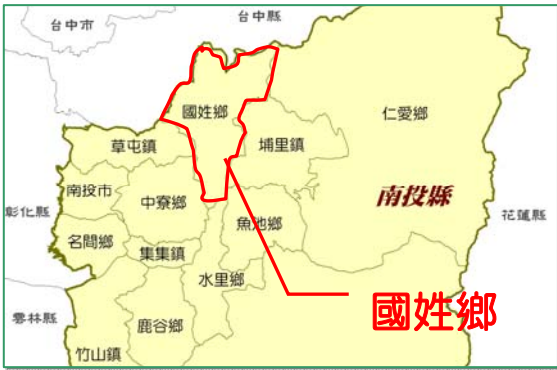
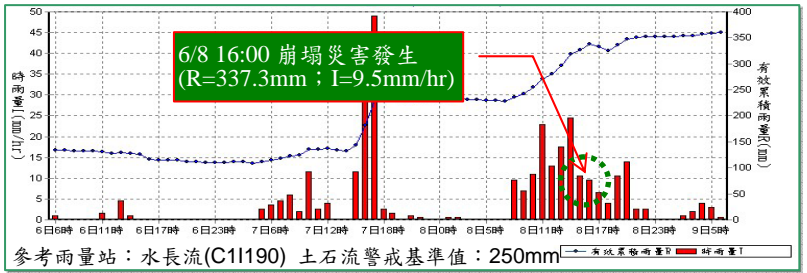
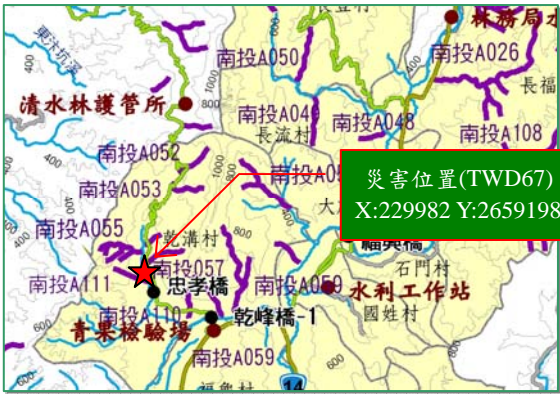
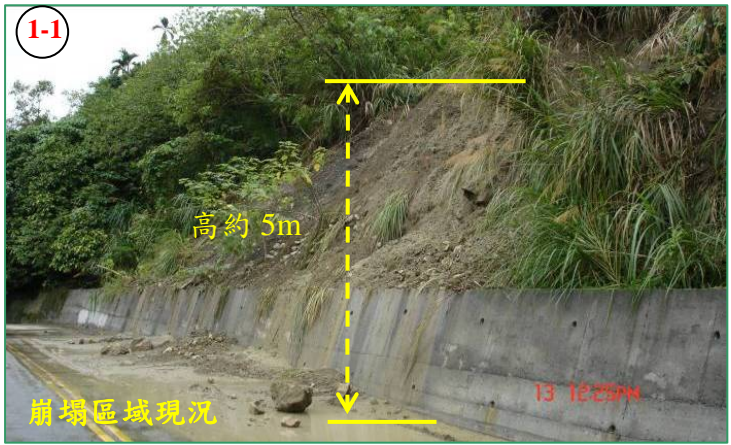
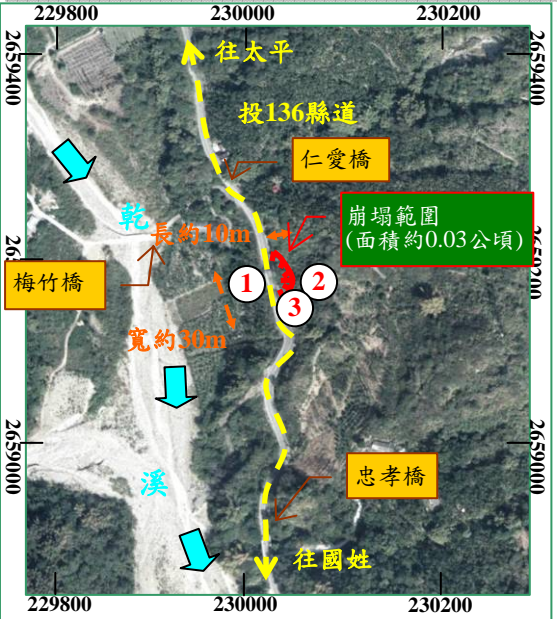
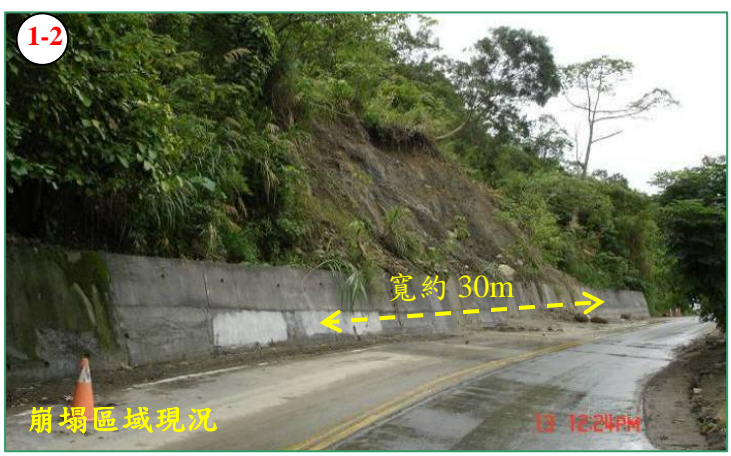
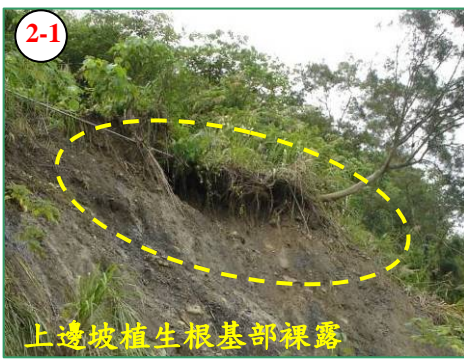
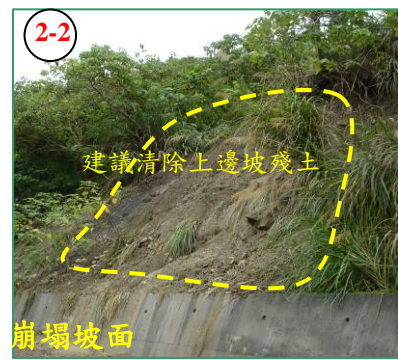
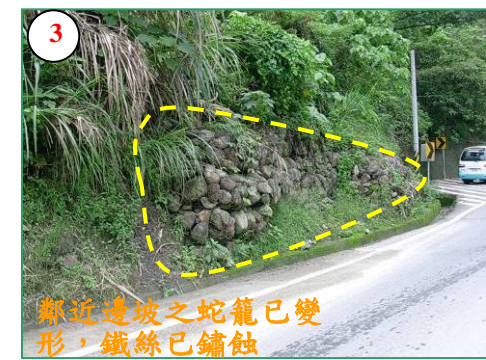
- ❖ 災區位置：國姓鄉乾溝村 (投 136 線 54.4k 處)
- ❖ 災害發生時間：6 月 8 日 16 時
- ❖ 災害類型：崩塌災害
- ❖ 有效累積雨量：337.3mm
- ❖ 災損描述與統計：
  - ✓ 投 136 縣道上邊坡土石鬆動，滑落投 136 縣道並阻斷道路。
  - ✓ 人命損失：0 人
  - ✓ 房舍受損：0 棟
  - ✓ 道路毀損：約 30 公尺。
