聖帕颱風

嘉義縣一中埔鄉石碇村

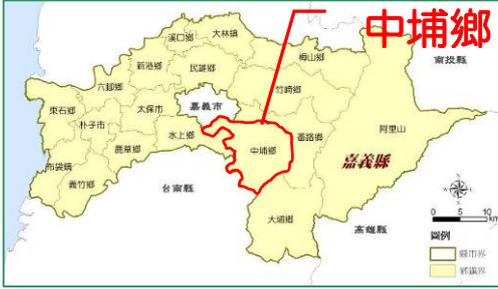
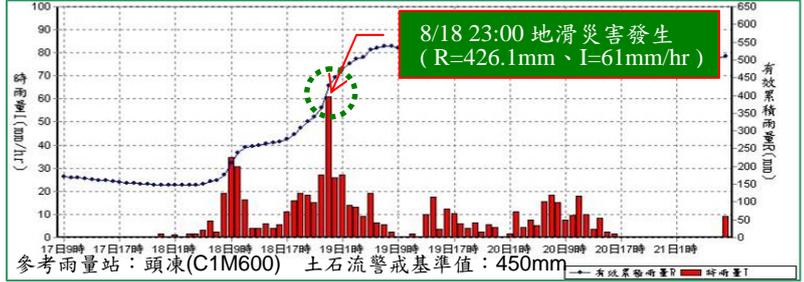
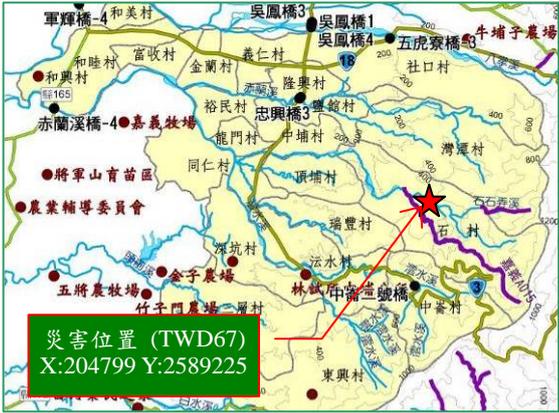
- ❖ 災區位置：嘉 135 鄉道 9.3k 處
 - ❖ 災害發生時間：8 月 18 日 23 時
 - ❖ 災害類型：地滑災害
 - ❖ 有效累積雨量：431.3mm
- ❖ 災損描述與統計：
 - ✓ 路基與道路邊坡崩塌，範圍寬約 120m，長約 20m，路面毀損約 150m，交通中斷。
 - ✓ 人命損失：0 人 ✓ 道路損毀：150 m
